## APPENDIX G

### Status of Spent Fuel in the Unit 1 Through 6 and Common Spent-Fuel Pools at the Fukushima Daiichi Nuclear Power Station

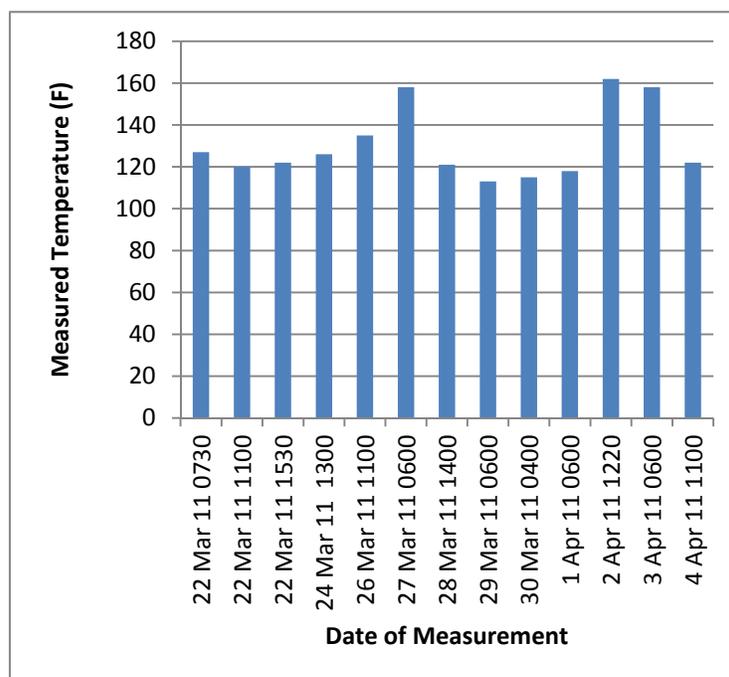
While the level history of the Unit 2 SFP is not known at this time, a partial history of measured SFP temperatures has been reported. This history illustrates the observed pattern of heatup and cooling of the SFP. Cooling occurred as a result of the periodic addition of water. As late as April 1, in the absence of the addition of water, the SFP temperature increased some  $22^{\circ}\text{C}$  ( $40^{\circ}\text{F}$ ) in 18 hours. This history is depicted in Fig. 1.

**Figure 1. Partial history of measured Unit 2 SFP temperatures.**
